Flood Control Project Maintenance
2009 Structure Summary Report
Overall Unit and Item Ratings

Madera County FCWCA

Flood Control Project Maintenance
Unit Cover Sheet
2009 Structure Inspection Results

Levee Inspection Report By Mile - Structure 2009

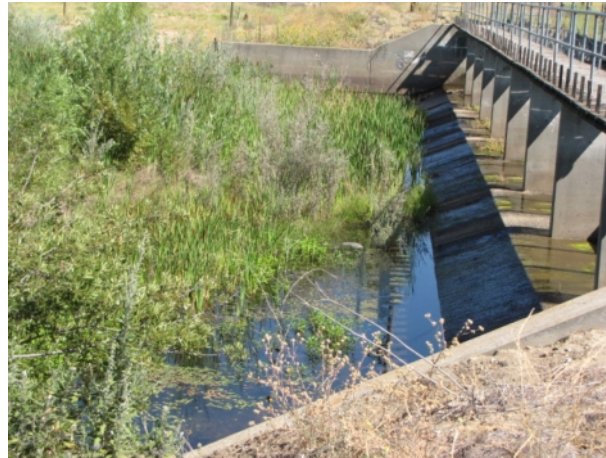
Levee Mile Report Line	1
Start Levee Mile	0.00
End Levee Mile	0.00
Location	Land Side
Category	Structures
Item	Photo Documentation
Downstream side of Berenda Control structure has wild growth within channel.	
phillips_20090804_1.jpg

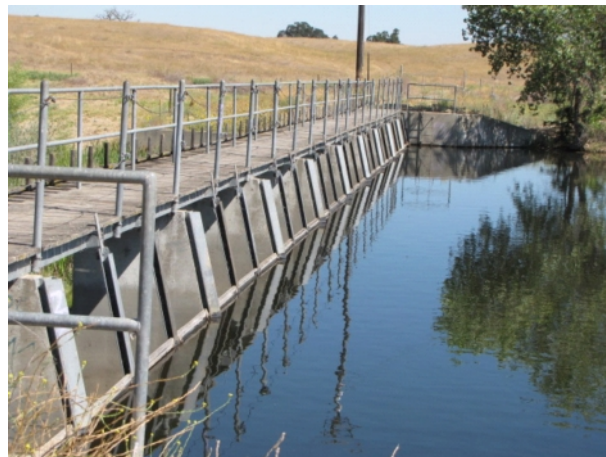
Levee Mile Report Line	1
Start Levee Mile	0.00
End Levee Mile	0.00
Location	Land Side
Category	Structures
Item	Photo Documentation
Up stream end of control structure is good.	
phillips_20090804_2.jpg

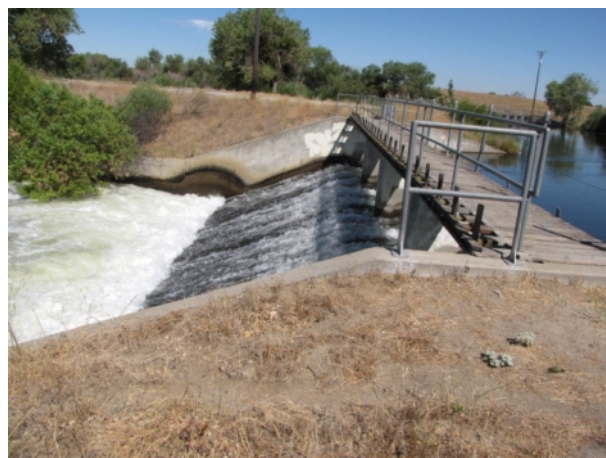
Levee Mile Report Line	1
Start Levee Mile	0.00
End Levee Mile	0.00
Location	Land Side
Category	Structures
Item	Photo Documentation
Ash Slough control structure.	
phillips_20090806_11.jpg

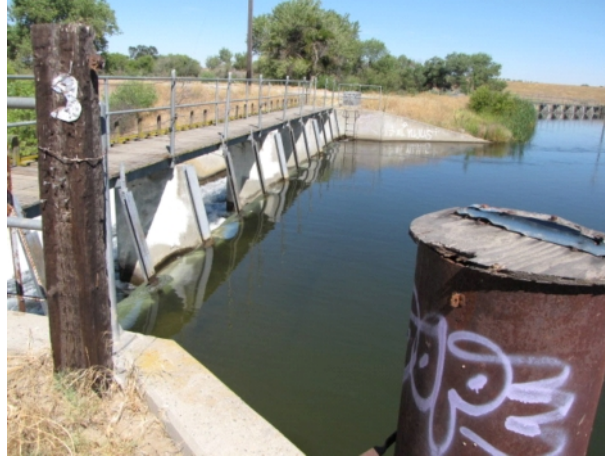
Levee Mile Report Line	1
Start Levee Mile	0.00
End Levee Mile	0.00
Location	Land Side
Category	Structures
Item	Photo Documentation
View of the structure control gates (timber). Berenda Slough contril structure in back ground far right.	
phillips_20090806_12.jpg

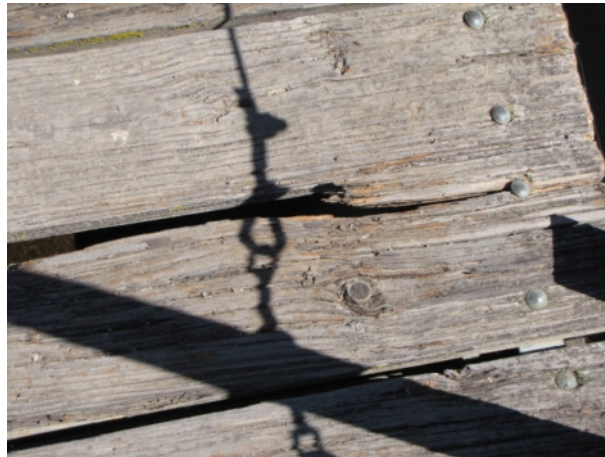
Levee Mile Report Line	23
Start Levee Mile	0.00
End Levee Mile	0.00
Location	Land Side
Category	Structures
Item	Safety
This picture shows where some of the boards are showing damage.	
phillips_20090804_3.jpg

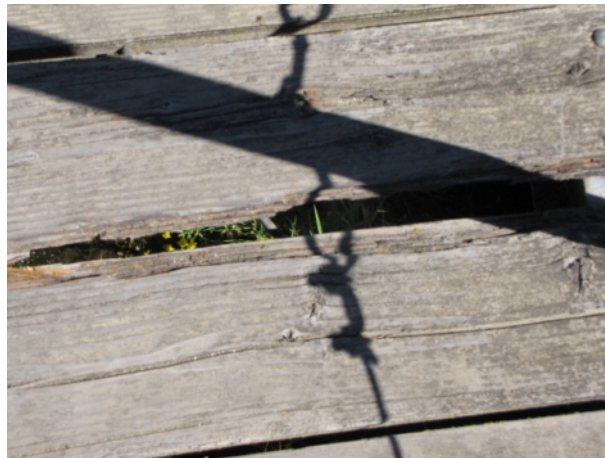
Levee Mile Report Line	23
Start Levee Mile	0.00
End Levee Mile	0.00
Location	Land Side
Category	Structures
Item	Safety
Board damage on cat walk.	
phillips_20090804_4.jpg

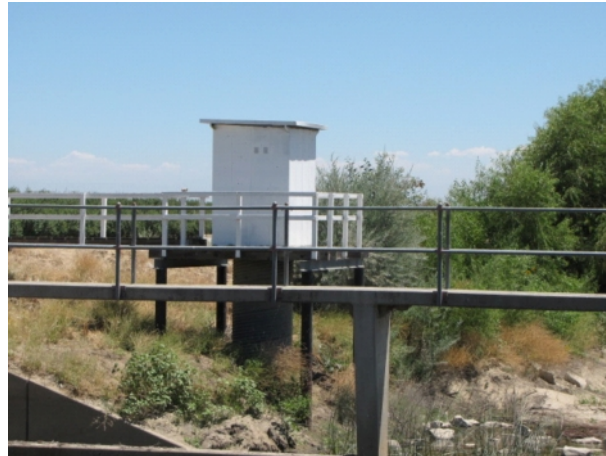
Levee Mile Report Line	1
Start Levee Mile	0.00
End Levee Mile	0.00
Location	Land Side
Category	Structures
Item	Photo Documentation
Photo of the control structure across the Fresno River. Recorder can with cat walk in view.	
phillips_20090806_7.jpg

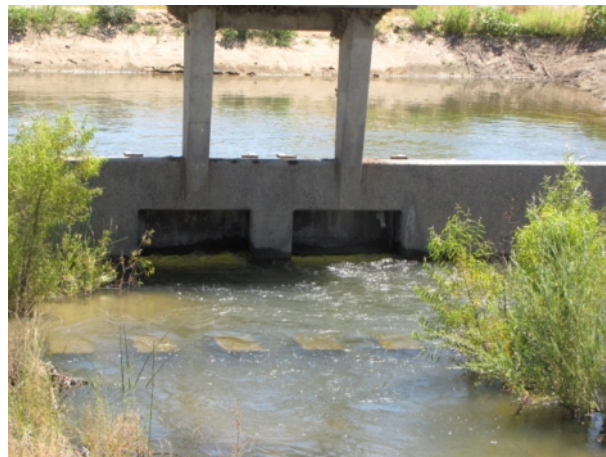
Levee Mile Report Line	2
Start Levee Mile	0.00
End Levee Mile	0.00
Location	Land Side
Category	Structures
Item	Vegetation & Obstructions
Vegetation present at the downstream end of the screw gate of the spillway crossing the Fresno River. View of the unauthorized earthen dam in back ground.	
phillips_20090806_6.jpg

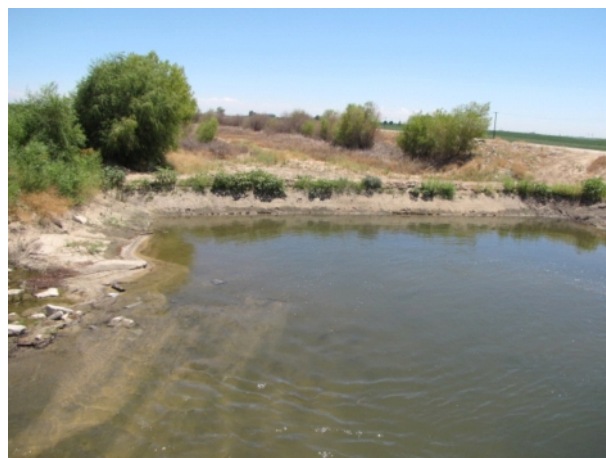
Levee Mile Report Line	5
Start Levee Mile	0.00
End Levee Mile	0.00
Location	Land Side
Category	Structures
Item	Encroachments
This is a photo of an earthen dam constructed across channel immediately upstream of the control structure in the Fresno River.	
phillips_20090806_5.jpg
